Surveying and diagnosing non-traditionally constructed houses in the United Kingdom

Journal of Building Appraisal (2009) 4, 239–245. doi:10.1057/jba.2009.5

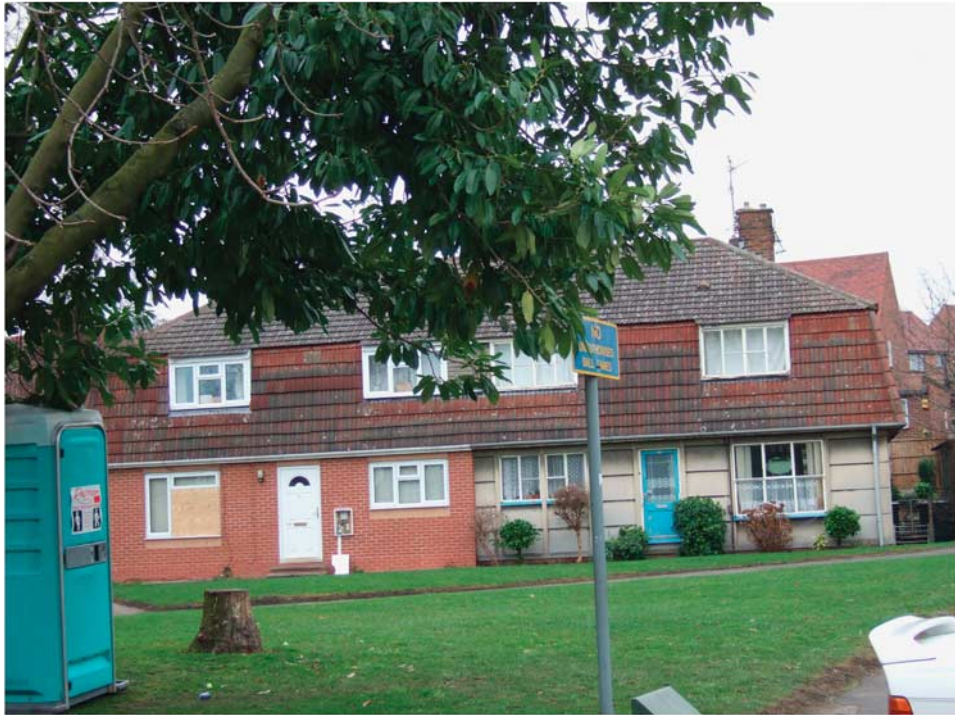
Figure 1: Original construction of small pre-cast concrete panels supported by pre-cast columns (right) and overlaid with brick (left).

The following illustrations were taken recently from a substantial development of concrete panelled houses located in a prime residential position in the centre of a small urban town. Figure 1 shows the original construction form of small pre-cast concrete

panels supported by pre-cast columns, in the semi-detached house to the reader's right, whereas the left hand property has been overlaid with brick. Many of these properties have become owner-occupied, and Figure 2 shows how once face-lifted with brick cladding and new UPVC fenestration they can be made aesthetically attractive. Figure 3 shows the different evolution of non-traditionally constructed semi-detached houses. The house left in its original form is now well past the original design life and consequentially the concrete panels, roof coverings and fenestration are all in extremely poor condition, and badly in need of exterior refurbishment.

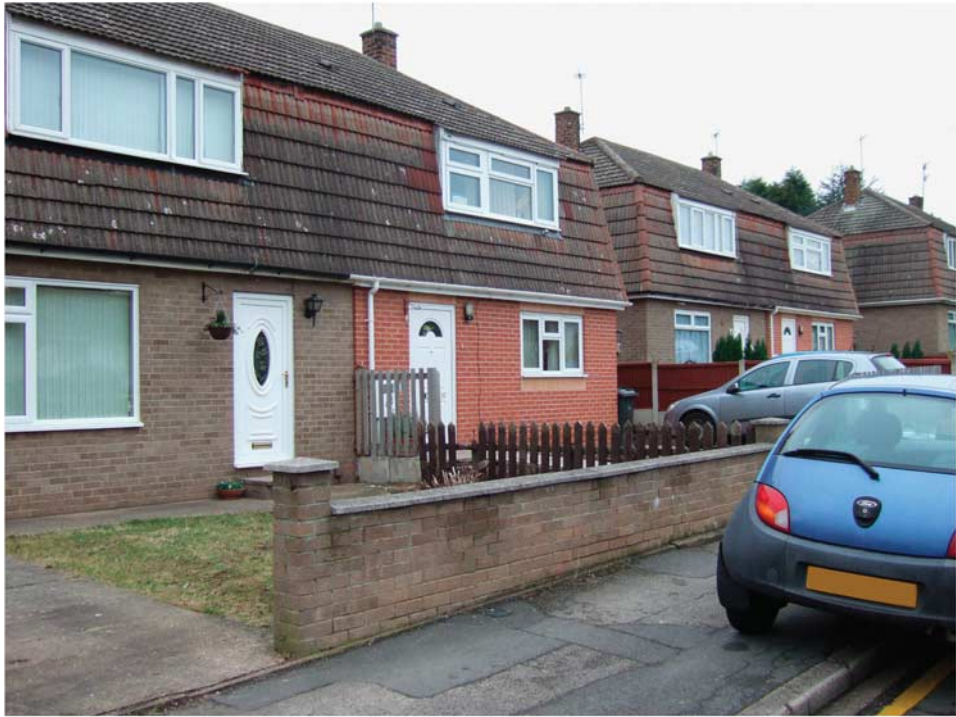
Figure 2: Once face-lifted with brick cladding and new UPVC fenestration, they can be made aesthetically attractive.

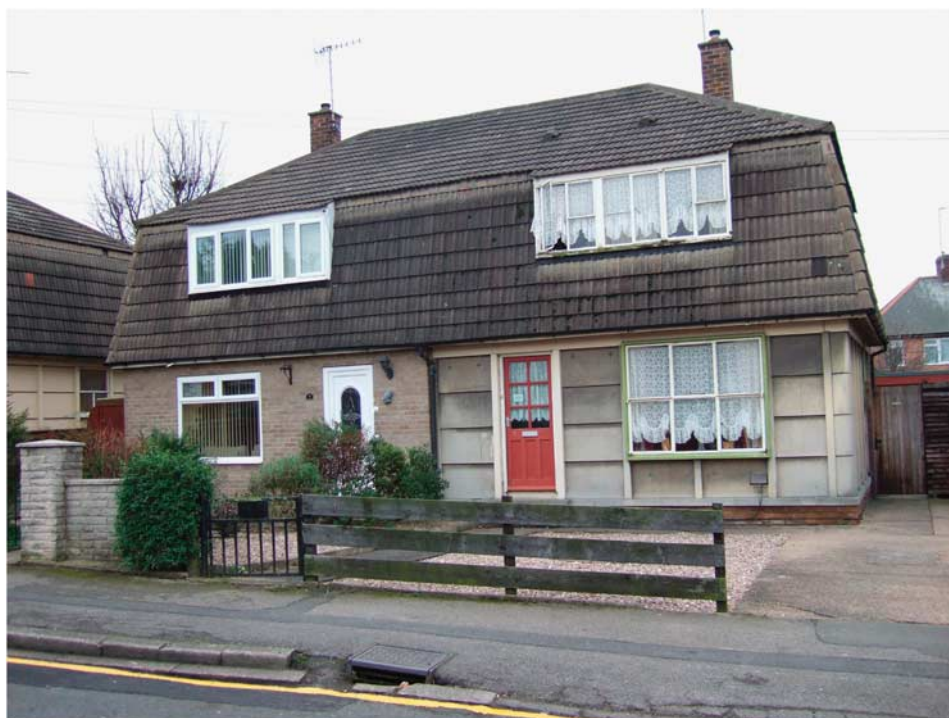
Figure 3: Different evolution of non-traditionally constructed semi-detached houses. The house still in its original form (right) requires significant refurbishment.

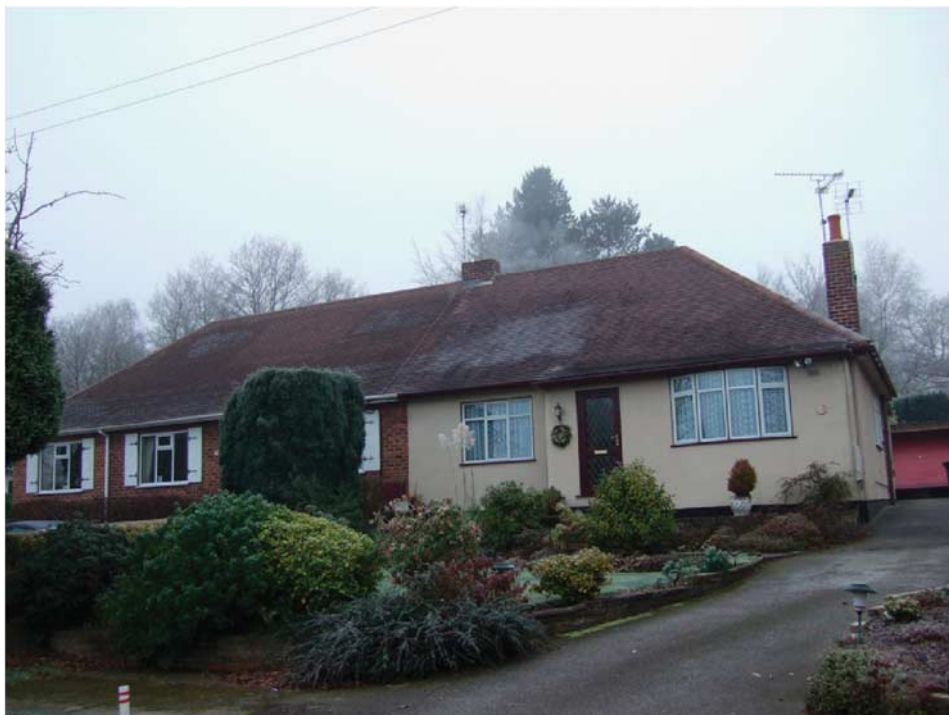
Figure 4: A pair of originally prefabricated semi-detached properties dating from the late 1950s which have evolved differently.

Figure 4 represents a pair of originally prefabricated semi-detached properties, which formed part of a small development reputedly dating from the late 1950s. It can be seen how the two semi-detached properties have evolved differently; however, the main issue with these would be that the area has evolved around them and they are now located in one of the most prestigious and expensive residential areas of the county.
